Manitoba  
Culture, Heritage  
and Recreation  
Historic Resources

# UKRAINIAN CHURCHES OF MANITOBA: A BUILDING INVENTORY

This examination of the architectural resources and the development of a typology of Ukrainian churches is based on material gathered for the Manitoba Heritage Council in February and March 1983 and on an inventory of the structures derived

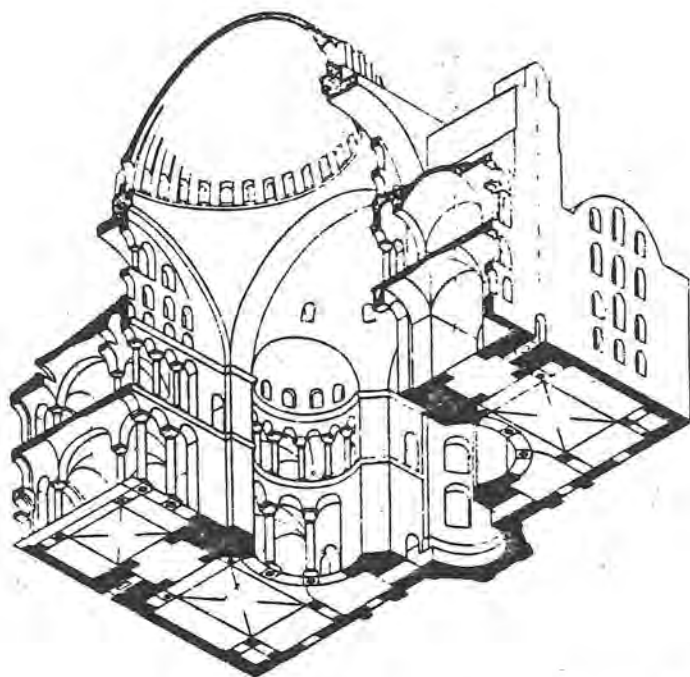
Plate 5. Hagia Sophia, Constantinople, (532-537 A.D.). Analytical half-section. (W. MacDonald, Early Christian and Byzantine Architecture, plate 55.)

The preliminary source for the architectural style of Ukrainian churches is that of Byzantine architecture. The Church of the Hagia Sophia in Constantinople (532-37 A.D.) was built in an innovative design, and greatly influenced its Ukrainian descendants (Plates 5 and 6). The Hagia Sophia combined a large dome over a cross plan to produce a dramatic yet quiet sense of mystery. St. Sophia in Kiev (1037-mid 1040s), in emulating the Hagia Sophia, became the model for eastern church design in Ukraine (Plates 7 and 8).

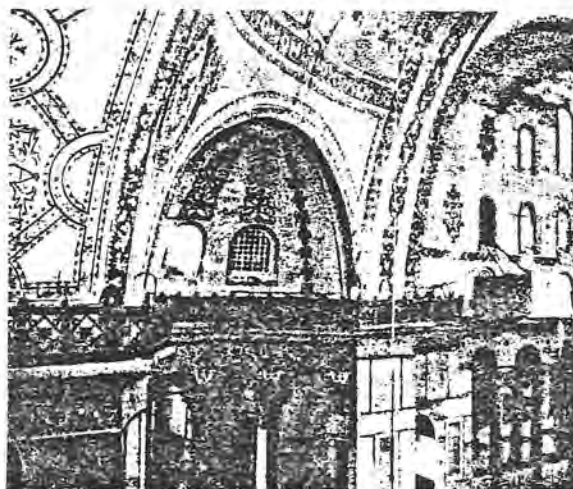
Plate 6. Hagia Sophia. Interior view of north and northwest superstructure. (W. MacDonald, Early Christian and Byzantine Architecture, plate 57.)

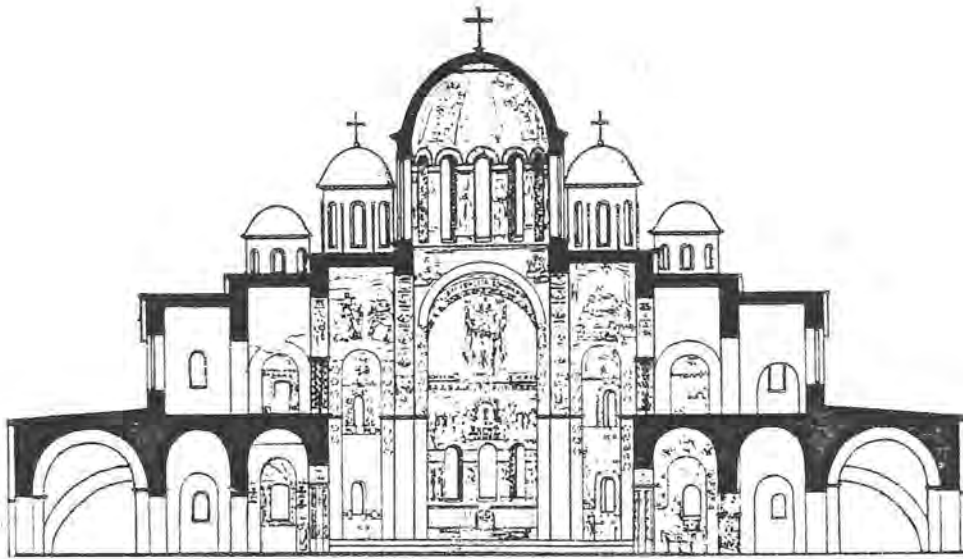
Plate 7. St. Sophia, Kiev, (1037-mid 1040s). Cross-section based on archaeological investigations. (O. Powstenko, *The Cathedral of St. Sophia in Kiev*, p. 32.)

Churches built in the larger urban centres of Ukraine were great stone structures whose plans were based principally on the Greek cross. These churches emphasized the vertical, having hemispherical domes set on drums, resulting in a large enclosed volume of space. The floor plan expressed the liturgical requirements

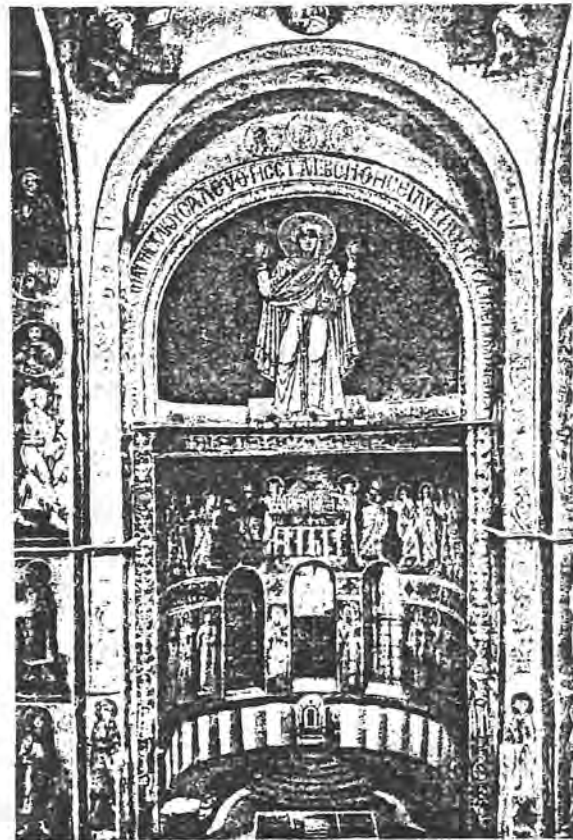
Plate 8. St. Sophia. Interior view showing the restored nave area. (O. Powstenko, *The Cathedral of St. Sophia in Kiev*, p. 97.)

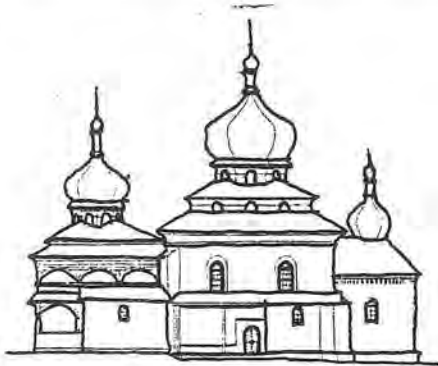
Plate 9. Church of the Holy Trinity, Nyzharkovychi in the Drohobych region (sixteenth century). (I. Asieiev et al., An Outline of the History of Architecture in the Ukrainian S.S.R., p. 91.)

The sixteenth century Church of the Holy Trinity, in the Drohobych region displayed elements of the transition to the Baroque style (Plate 9). The Chapel of the Three Saints (Plate 10) built in 1578 also had many of the sculptural and classicizing elements which typified Baroque structures.

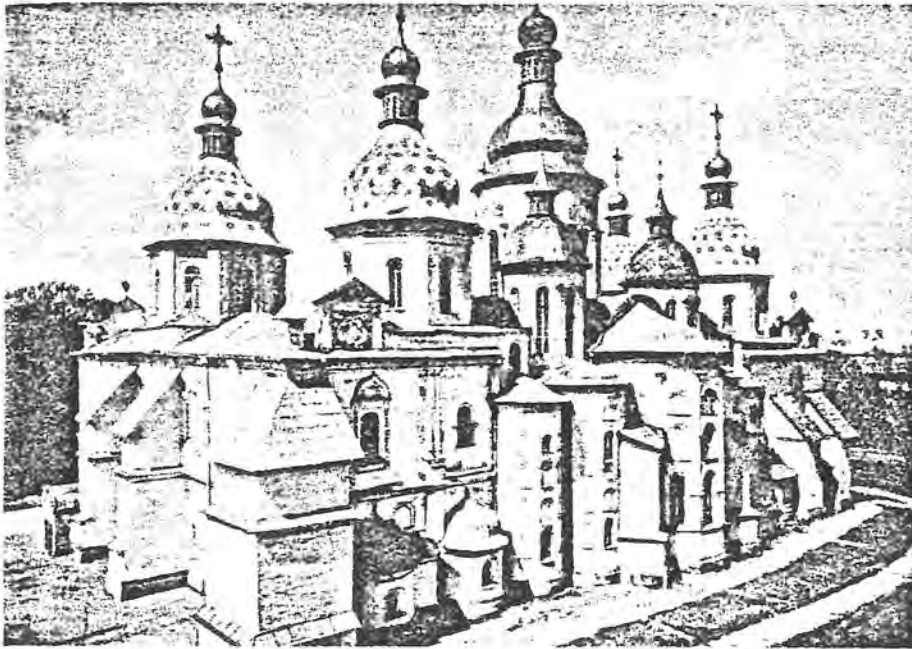
Plate 11. St. Sophia, Kiev. The central five apses of the original eleventh century structure form the nucleus of the enormous seventeenth century structure. The present exterior is almost entirely the result of additions in the Ukrainian Baroque style. (D. Buxton, Russian Medieval Architecture, Plate 57.)

independence, that there arose a resurgence of Ukrainian art. The first examples of Ukrainian or Kozak Baroque emerged as early as the first half of the seventeenth century; but not until the second half did it flourish. Its development was the result of a greater contact with mainstream western European art primarily in areas under Polish domination. The original St. Sophia in Kiev was restored and enlarged during this period, the result being a complete break with the Byzantine style in the design of subsequent structures (Plates 11 and 12).

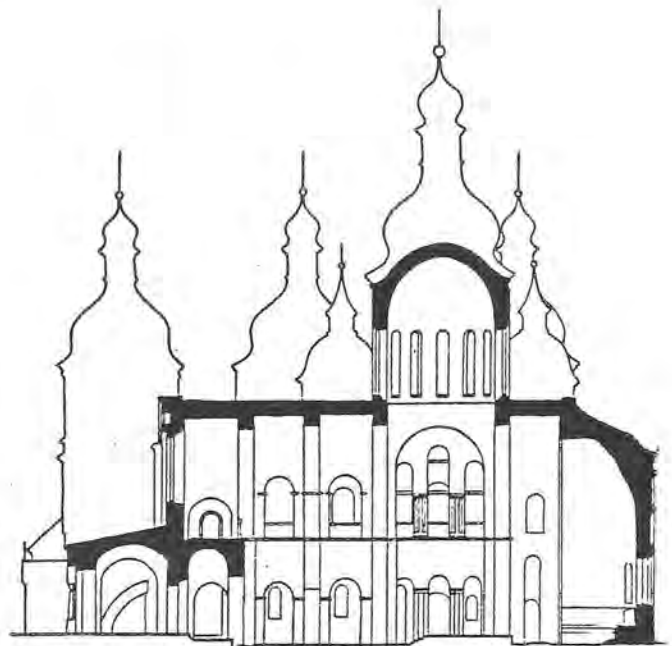
Plate 12. St. Sophia. This longitudinal section through the nave reveals the eleventh century core, in black, surmounted by the later Ukrainian Baroque additions. (H. Lohvyn, Across Ukraine: Early Artistic Monuments, p. 53.)

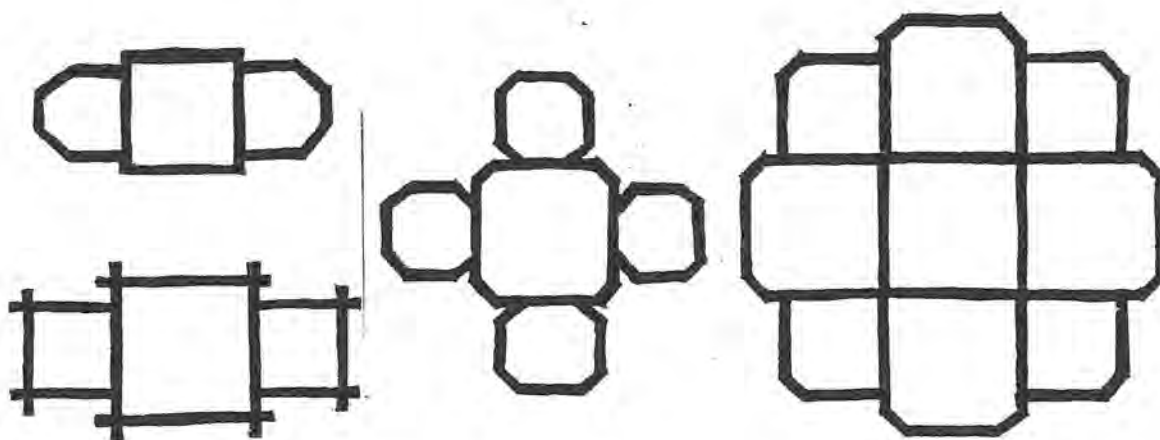
Plate 13. Examples of three, five and nine frame plans. (Redrawn from V.

Sichynsky, Ukraine: A Concise Encyclopedia, p. 532.)

The basic designs of Ukrainian wooden church architecture had developed during the tenth and eleventh centuries. There were several basic types of plans that characterized subsequent wooden churches (Plate 13).

than the adjacent two. An addition of two frames to the foregoing three produced a five frame plan, also fairly common. Four smaller frames added to the inside corners of the cross plan produced a nine frame church. A seven frame plan was formed when two towers were added to the front of a five frame church.

The simplest were the one and two frame plans. (In this context, a frame is analogous to a space or a room of either modest or grand proportions. These straightforward two-dimensional compositions attained complexity externally as each frame found its own distinct three-dimensional identity, with towers, domes and cupolas, known in Ukraine as banyas.) The development of more sophisticated churches essentially meant the addition of frames. The most common plan was the three frame church, with the central frame usually somewhat larger

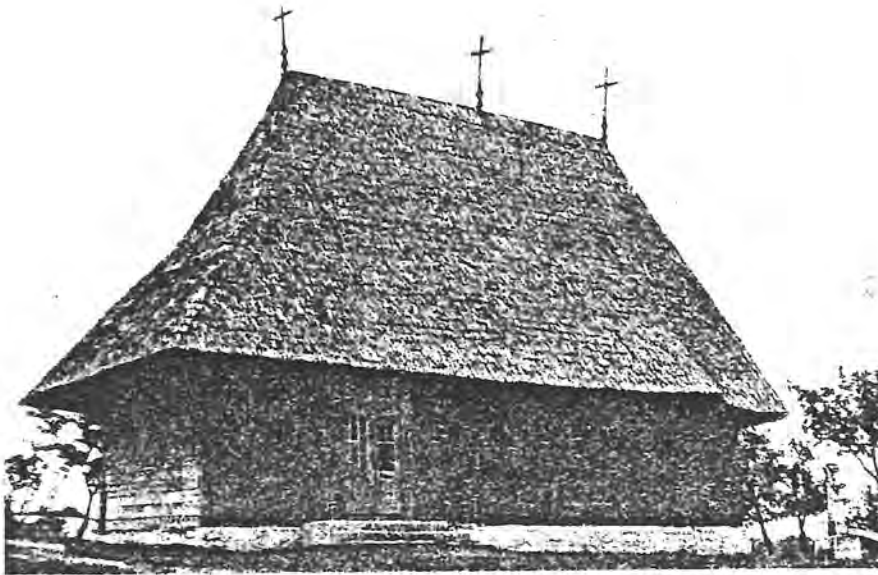
Plate 14. Church of the Holy Trinity in the suburb of Klokuchka in Chernivtsi (1774). (H. Lohvyn, Across Ukraine: Early Artistic Monuments, p. 332.)

Church of the Holy Trinity in Chernivtsi (1774) with its steep pitched roof (Plate 14); St. George's at Drohobych (Plate 15); and the three-frame churches in Krechiv and Chortkiv, with their elaborately shingled domes (Plates 16 and 17). All are of log construction and display features such as the large dome, banyas, tall crosses and bell towers - which typically sit detached - that distinguish these as churches from Ukraine. And, most importantly, these are the buildings which clearly form the precedents for many Ukrainian

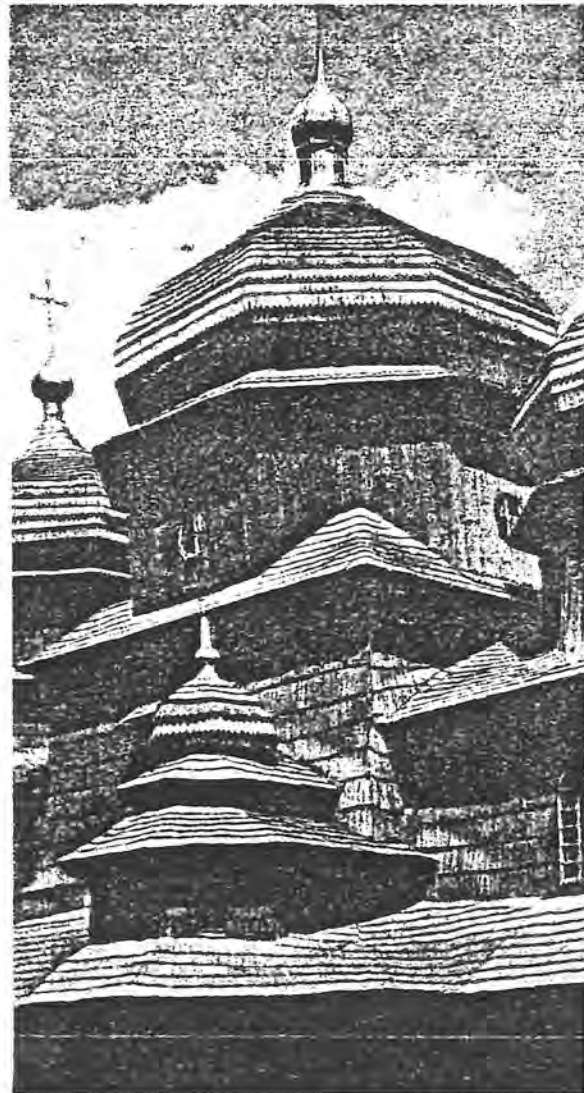
Plate 15. St. George's Church in Drohobych (seventeenth century). (H. Lohvyn, Across Ukraine: Early Artistic Monuments, p. 354.)

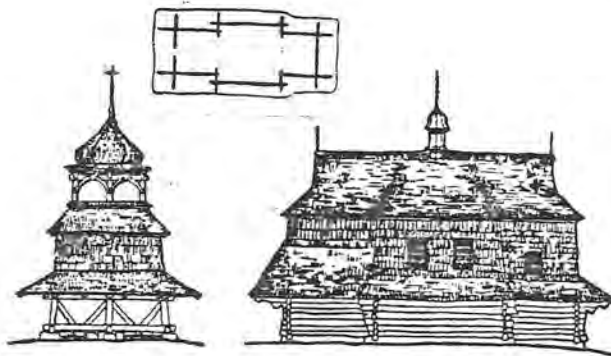
Plate 16. Church and belfry in Krechiv in the Lviv region (1658-1724). (I. Asieiev et al., An Outline of the History of Architecture in the Ukraine S.S.R., p. 215.)

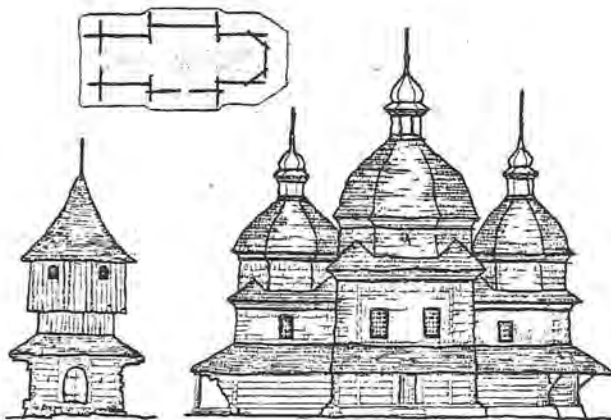
Plate 17. Church of the Dormition with its attendant belfry, Chortkiv (seventeenth century). (I. Asieiev et al., An Outline of the History of Architecture in the Ukraine S.S.R., p. 222.)

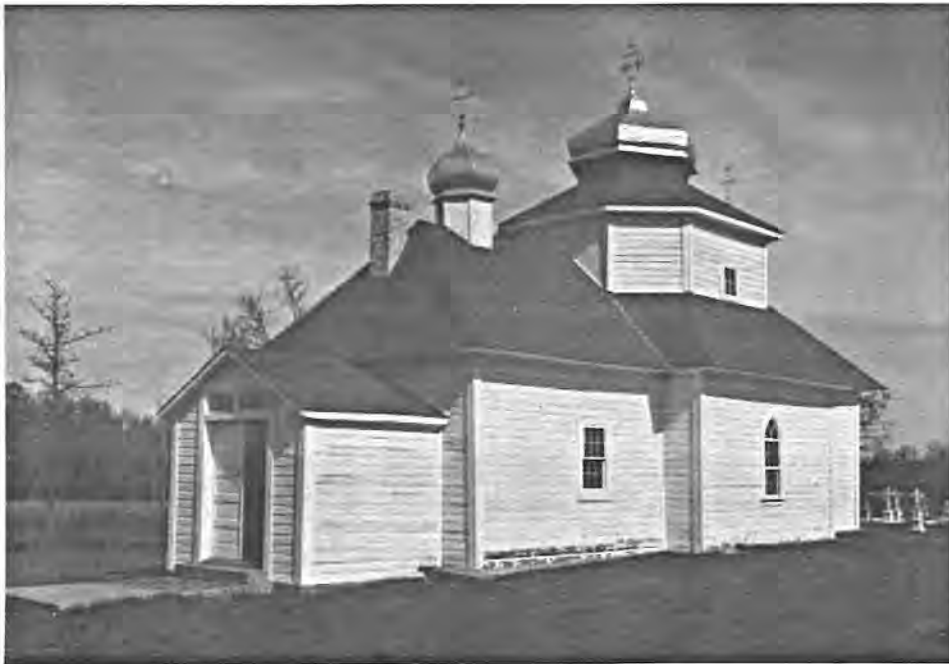
Plate 19. St. Michael's Ukrainian Greek Orthodox Church, Gardenton. The plan of the church -- three frames orientated on an east-west axis with the central frame slightly larger than the adjacent two -- has remained basically unaltered.

Foremost among log Ukrainian churches is St. Michael's Orthodox Church at Gardenton, consecrated in 1899 (Plate 19). At first this building had a straw-thatched low-pitch gable roof, with the middle section jutting out to form the traditional central frame of the Ukrainian church plan. Within two years, however, the thatch roof was replaced by shingles and the oak, ash, cedar and tamarack logs were covered with siding. The plan of St. Michael's has remained basically unaltered and is the type most popular in Ukraine: three frames orientated on an east-west axis, with the central frame slightly larger than the adjacent two.

In 1915, the old roof, which had rotted and leaked badly, was replaced by the present roof and dome structure, designed by Menholy Chalaturnyk, also the designer of the church at Sirko. This carpenter/builder rebuilt the roof according to examples remembered from his native Bukovyna and completed it by the fall of 1915. The drum is octagonal, pierced at its base by two small square windows on the north and south sides. Capping this is a single dome, edged by a strip of decorative trim and covered by tin. Chalaturnyk also placed two small cupolas at the ridge of the hipped roofs, over the outer frames. These are also encased in tin and, unlike the large

When Chalaturnyk made these renovations to the design of St. Michael's church in 1915, he also removed the entrance door from the south side near the west corner and built a new double doored porch entry at the west end, similar to the churches at Sirko and Lennard. The markings of the original doorway can be discerned around the window which replaced it.

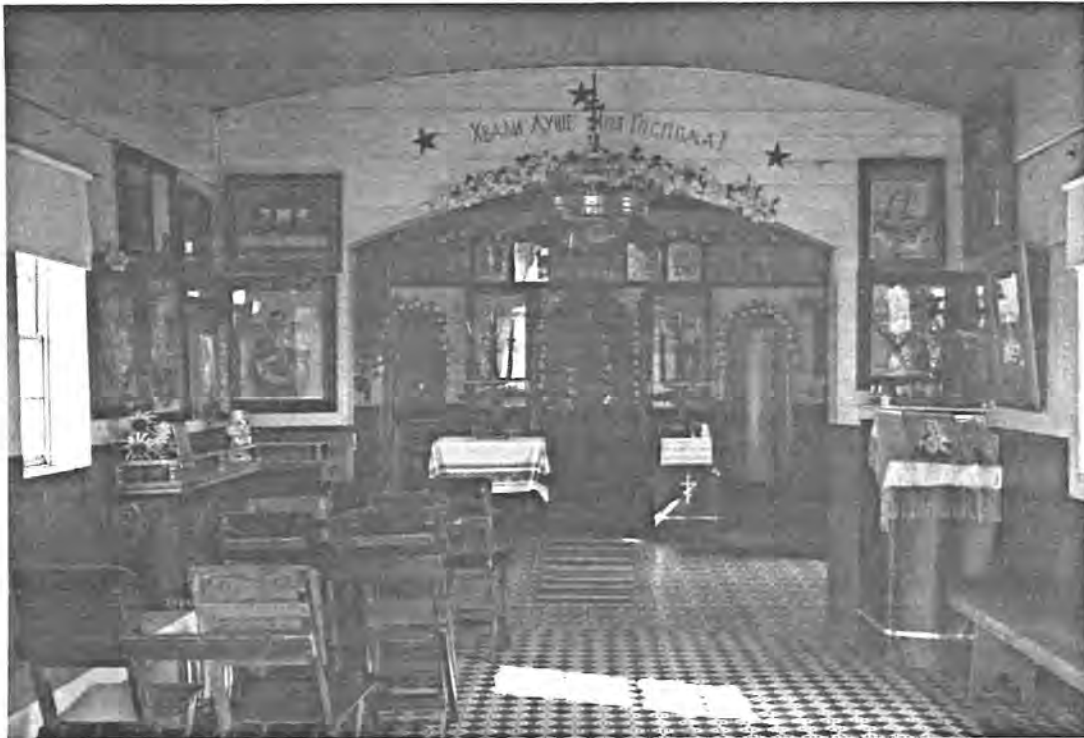
Plate 20. St. Michael's Church, Gardenton. This view into the west frame shows the icons and the impermanent seating.

The interior of St. Michael's, Gardenton, reflects the splendour and love of brilliant colour and decoration

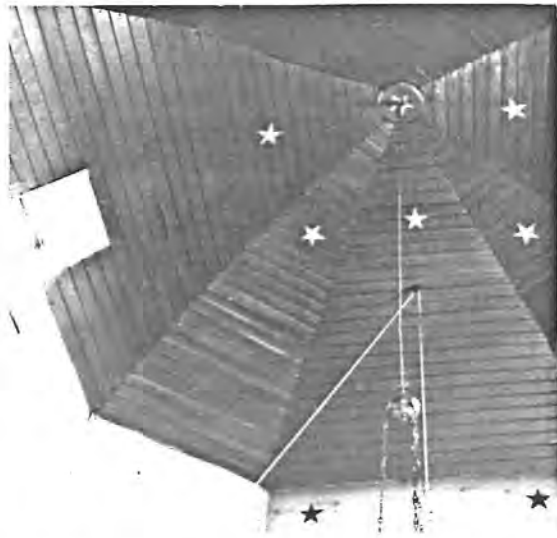
Plate 21. St. Michael's Church, Gardenton. Interior of the dome.

found in the Eastern Church. Entering through the front door, the worshipper is drawn into a series of spaces. From the entrance to the iconostas, movement was originally unobstructed by seating, with the exception of a few benches placed against the walls for the elderly. Devout parishioners were required to stand during the service. Moving forward from the small porch, it is necessary to step up into the west end frame - a shallow barrel-vaulted room lined by brightly painted planking (Plate 20). Small hand-fashioned shelves and a variety of icons enclose the east corner; a brass chandelier hangs from above. Passing beneath the devotional expression inscribed above the arched partition opening, "Our Hope is in God", written in Ukrainian, the worshipper enters the large domed central space (Plate 21). Overhead,

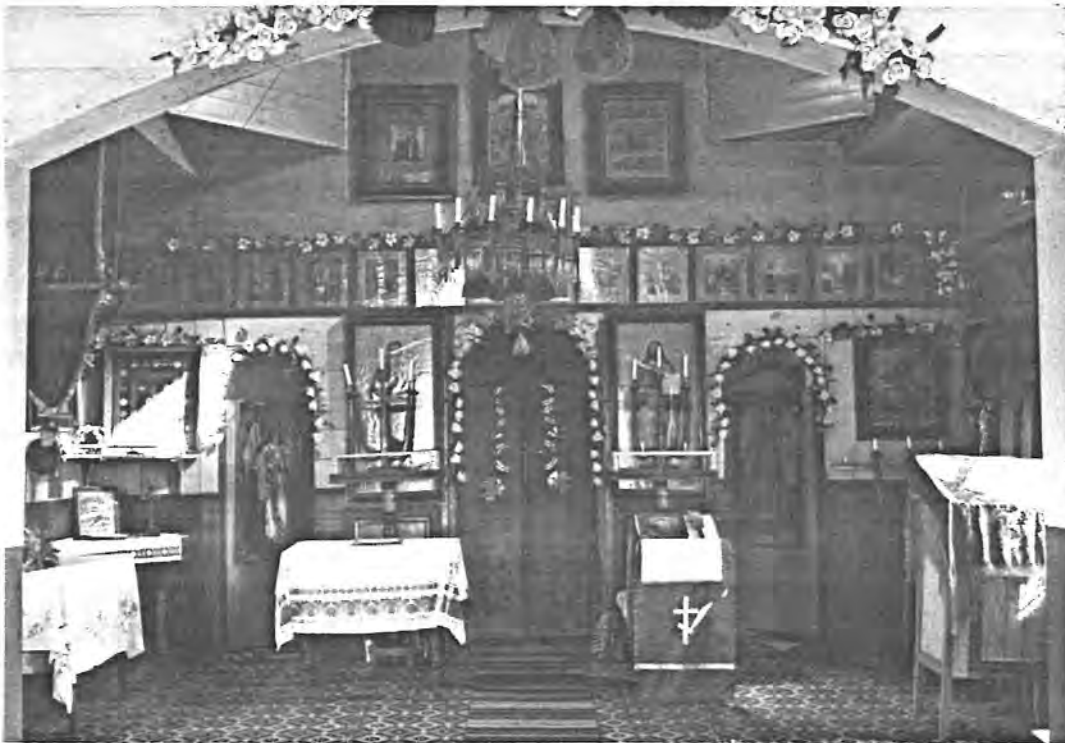
Plate 22. St. Michael's Church, Gardenton. Ceremonial arch and altar area.

The iconostas, designed by Wasyl Chornopysky, is covered from floor to dome with framed icons, many of which were imported from Kiev, St. Petersburg, Moscow and Odessa and donated by the parishioners (Plate 22). The screen is pierced by the traditional three openings, with the Royal Doors of the central portal decorated by fretwork. Chornopysky also carved the colourful candelabras, scripture stand and table as companion pieces to the large wooden cross, dated 1902. Pennants and banners donated by the early parishioners stand against the partition walls of the central nave. Several fine objects lie upon the altar within the sanctuary (Plate 23). The large Holy Gospel, printed in Church Slavonic, is bound in red velvet with engraved metal plates and clasps. The chief carpenter of the original church, Wasyl Kekot, had carved an intricate wooden cross, dated 1897, for the church's consecration. Two years before the reconsecration ceremony, held in the fall of 1915, he fashioned a new crucifix. Both crosses, displayed in the church, exhibit exceptional skill and beauty.

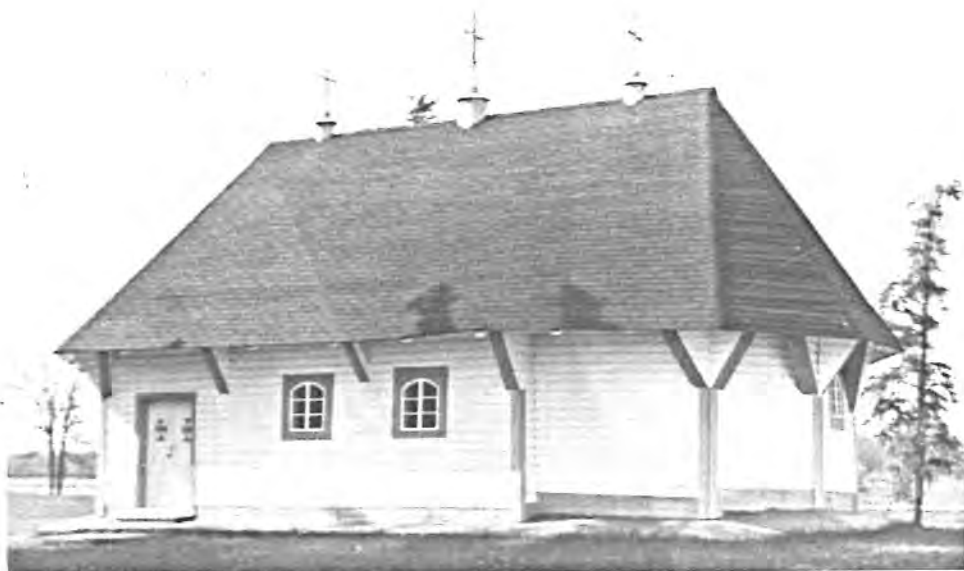
Plate 24. St. Elias Ukrainian Orthodox Church, Sirko.

The corners of the old church are probably of dovetail construction. The whole of the exterior was mud-plastered and whitewashed. Later this covering was hidden by wooden

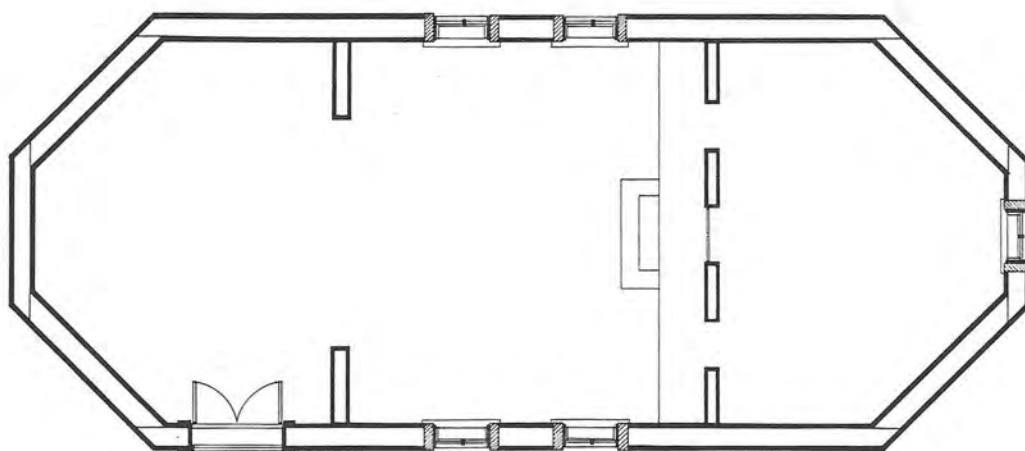
Plate 25. Floor plan. St. Elias Ukrainian Orthodox Church, Sirko.

built on a rectangular plan extended on the short sides with curved vestibules and altars (Plate 25). The roof shapes of both are reminiscent of the broad thatched roofs of Ukrainian houses, but are distinguished from other early Ukrainian churches by the eave, which sweeps uninterrupted around the building.

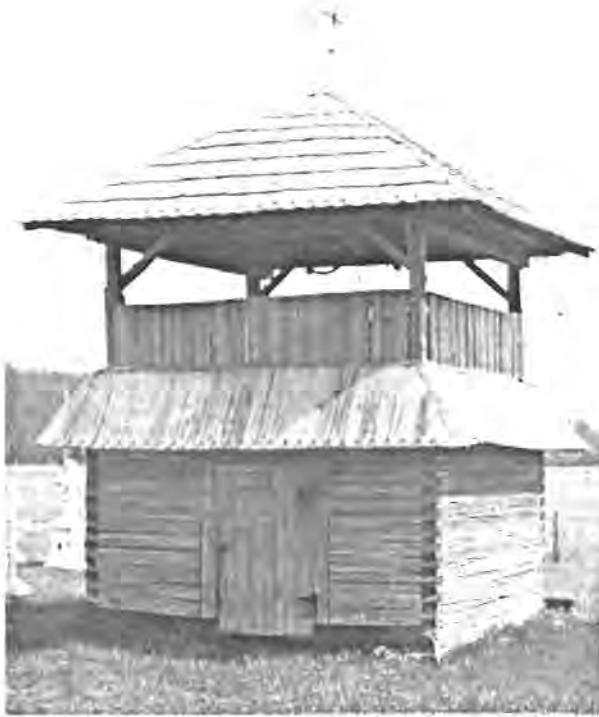
Plate 26. Bell tower of St. Elias Church, Sirko. The roof of the tower is built of roughly laid vertical shakes similar in nature to planking. Bell towers were a ubiquitous feature on Ukrainian churchyards in Manitoba, just as they had been in Ukraine. Those in Manitoba were, like this one, simply constructed and animated with a few functional, but decorative elements.

horizontal siding. The corners of the free-standing bell tower, however, have their dovetail joints exposed (Plate 26). The beams and joists used to construct the upper tower are joined with fairly elaborate connections which have been pegged. The same construction techniques were likely used in the church.

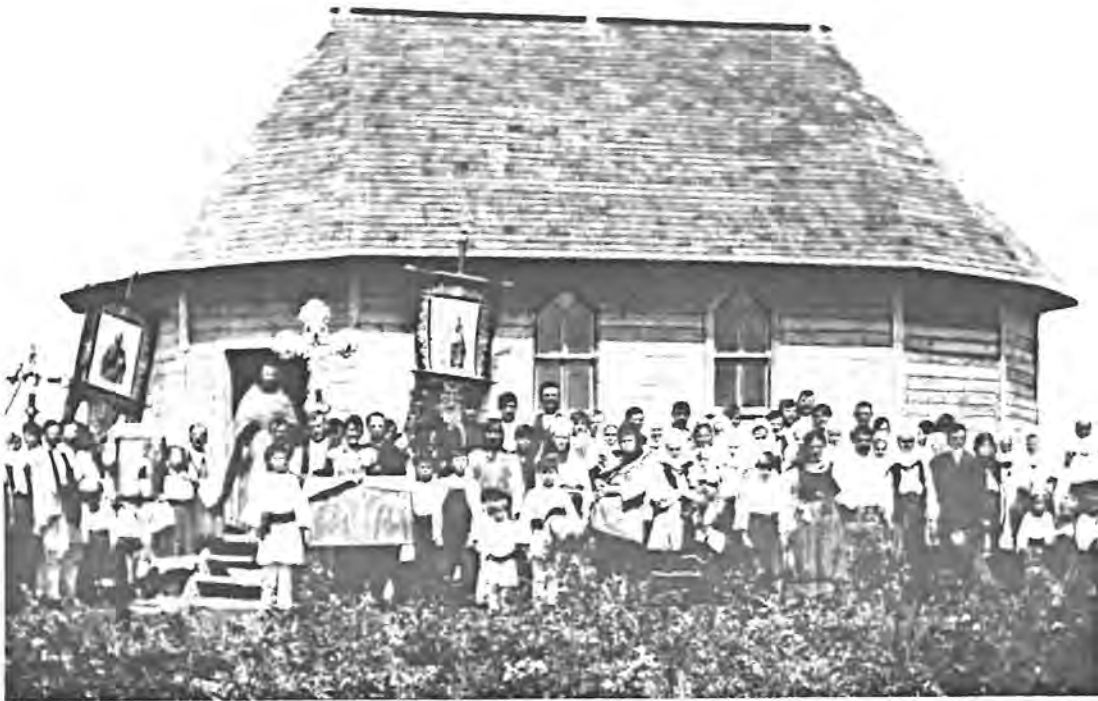
Plate 27. St. Elie Church, Lennard, shortly after its construction. (St. Elie Romanian Orthodox Church Museum.)

St. Elie was built in 1908, replacing a smaller log edifice from 1904 (Plate 27). Between 1903 and 1904, until the first church was built, services were held out-of-doors.

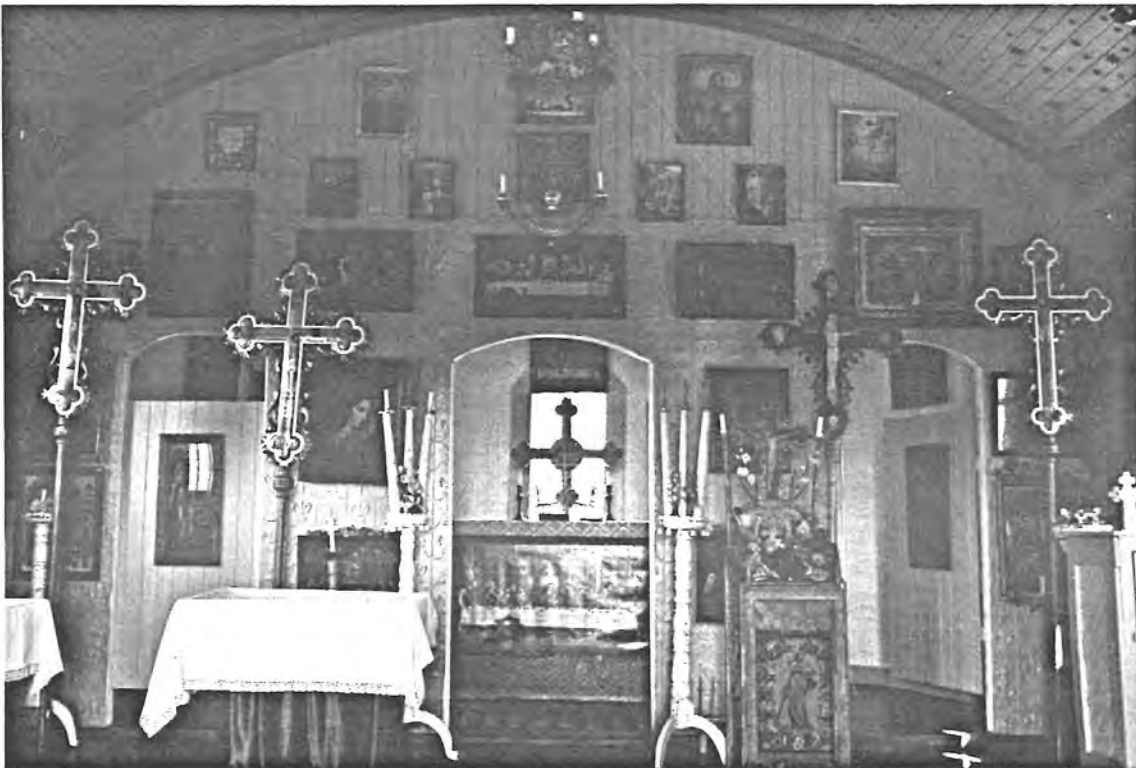
Plate 28. St. Elie Church, Lennard.  
This view shows the iconostas and icons.

into a small vestibule. Above is the balcony for the cantor (ritual singer). A few short steps beyond is the nave. The view towards the iconostas is, as usual, unobstructed by any seating (Plate 28).

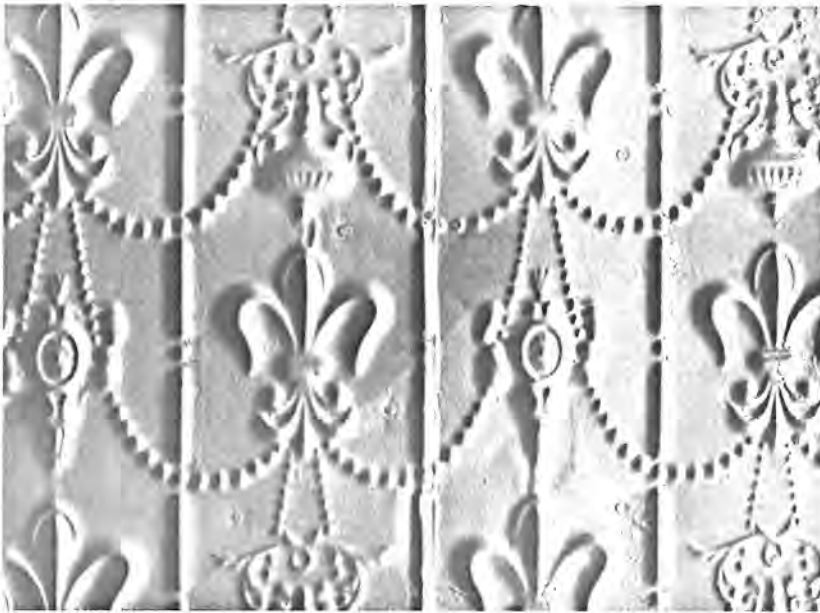
Plate 30. St. Elie Church, Lennard.  
Detail of sheet metal wall panels.

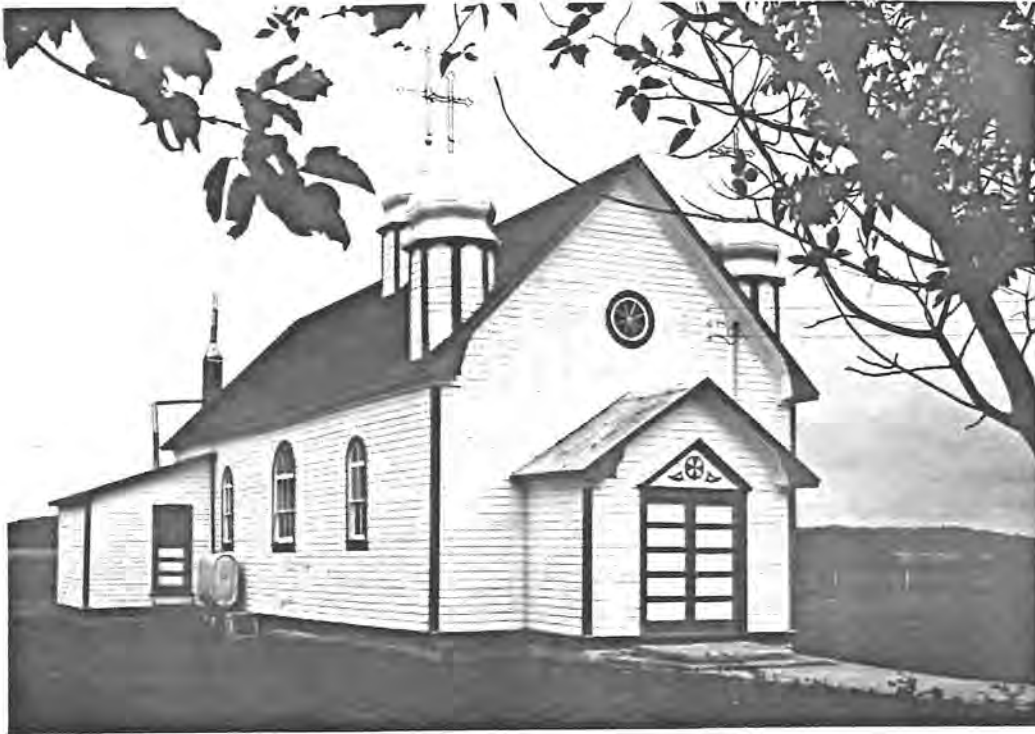
Plate 31. Holy Eucharist Ukrainian Catholic Church, Horod. This small white and green building is a noted local landmark.

This wood frame church was erected between 1922-23 under the direction of Michael Hawrysh, a local carpenter/builder (Plate 31). The original cost of this structure was approximately \$2,500 and the building was probably constructed with much volunteer labour.

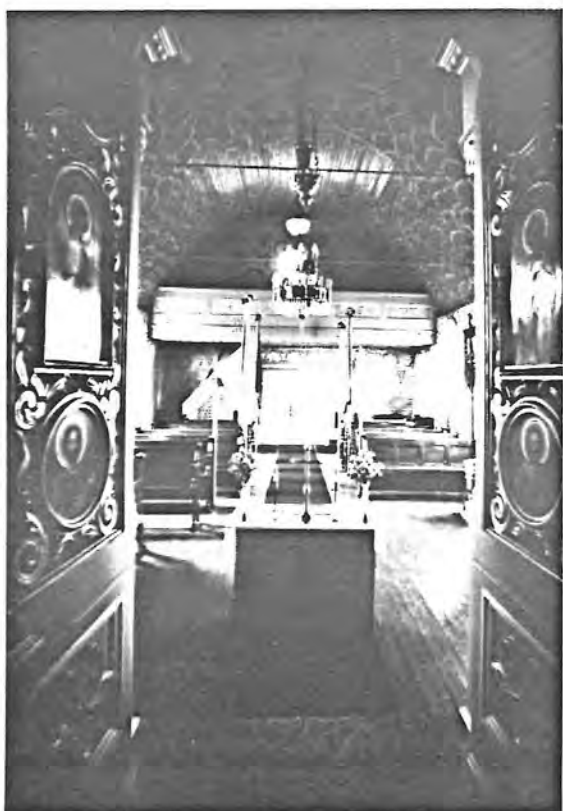
Plate 32. Holy Eucharist Church, Horod. View of the church from the central or Royal Gate in the iconostas looking west to the rear and the cantor's loft.

Although the church has a gable roof - marked by three banyas - the interior boasts a barrel vault finished with tongue-and-groove boards with V-joints (Plate 32). The barrel vault is painted with representations of clouds upon a blue background. The walls are also decorated with a cloud motif, while the painted wainscoting is finished with a stencilled leaf pattern (Plate 33). The central opening of the iconostas is barred by a heavily-gilded pair of round-arched gates. These contain four medallion icons representing the Evangelists - Matthew, Mark, Luke and John - traditional portraits found on the Royal Doors.

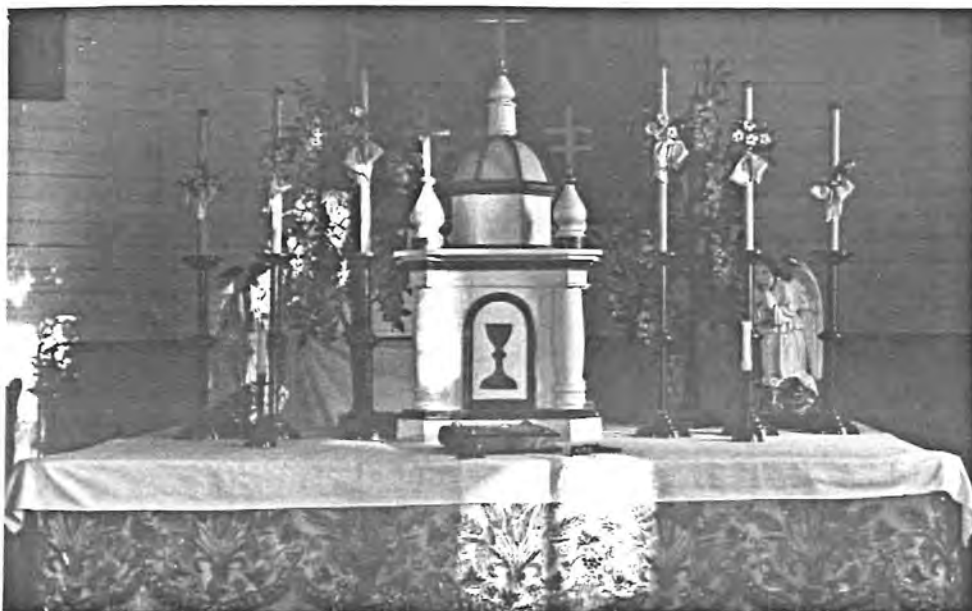
Plate 36. Holy Ghost Ukrainian Catholic Church, Merridale. The tabernacle on the altar is a miniature Ukrainian Cathedral.

There is no iconostas, although there are several small icons on the walls of the sanctuary with a large oil painting behind the main altar. Upon the altar is an elaborately-bound Bible. The handmade tabernacle, flanked by tall brass candlesticks, takes the form of a traditional Ukrainian church, with a large central dome and banyas (Plate 36). While the fine religious objects show fine ornamentation, the overall interior effect remains one of considerable simplicity.

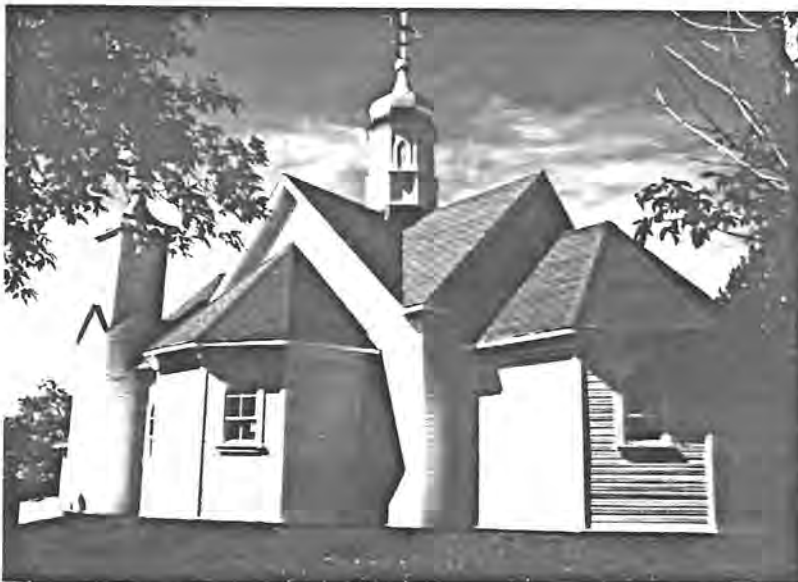
Plate 38. St. Michael's Church, Olha. This view shows the apsidal transept and chancel.

The plan of St. Michael's is cross-shaped and can be considered five-framed. The short arms of the cross -- the apsidal transepts -- contain side altars (Plate 38). Two towers with banyas adorn the front façade of the structure, with a small central cupola atop a two tier drum at the centre of the gable crossing.

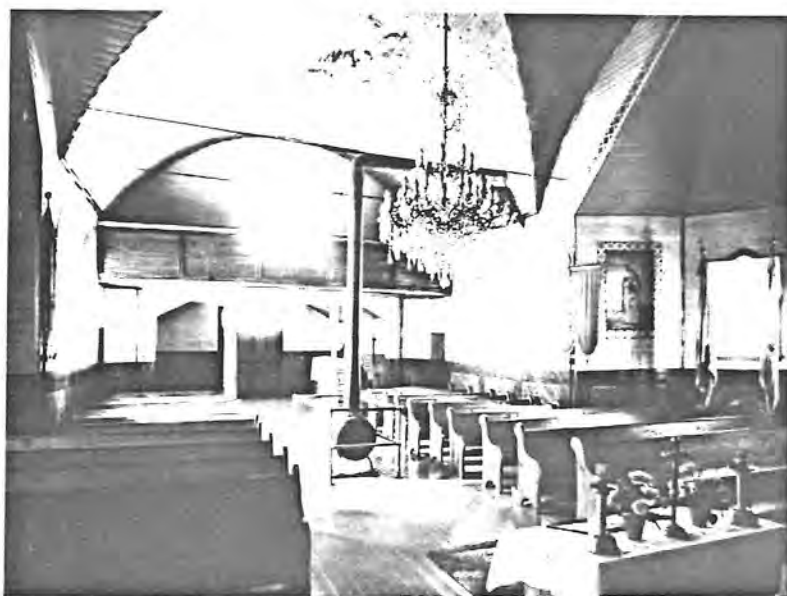
Plate 39. St. Michael's Church, Olha.  
The vaulted apsidal chapels and nave  
contribute to the sense of spaciousness  
in the church.

The interior of St. Michael's, Olha features many colourful wall murals and portraits, as well as gold stars painted on a heavenly blue vault (Plates 39 and 40). Banners and faux marble -- painted wood and plaster -- wainscotting add to the overall impact. The iconostas is a solid wall adorned with gold leaf and small individual icons (Plate 41).

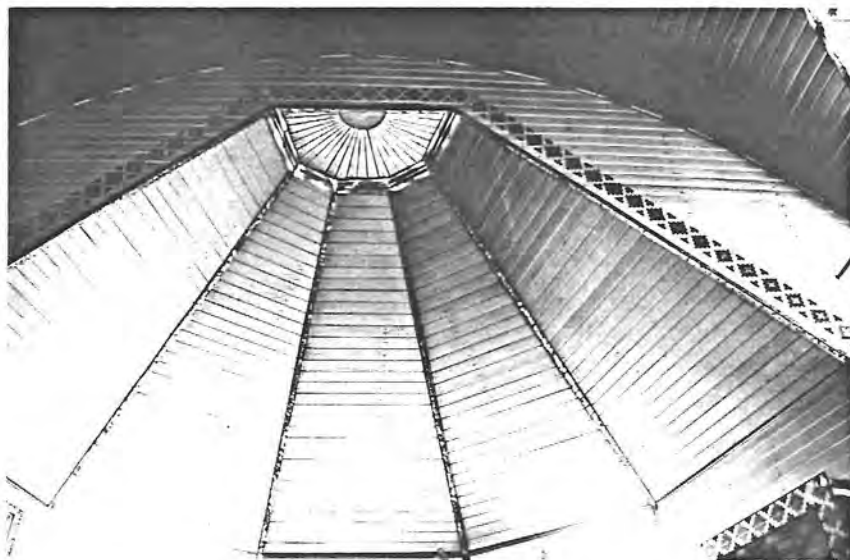
Plate 40. St. Michael's Church, Olha.  
From the middle of the ceiling the sun  
shines down in painted radiance, the  
interstices between the roof segments  
gilded in imitation of solar rays.

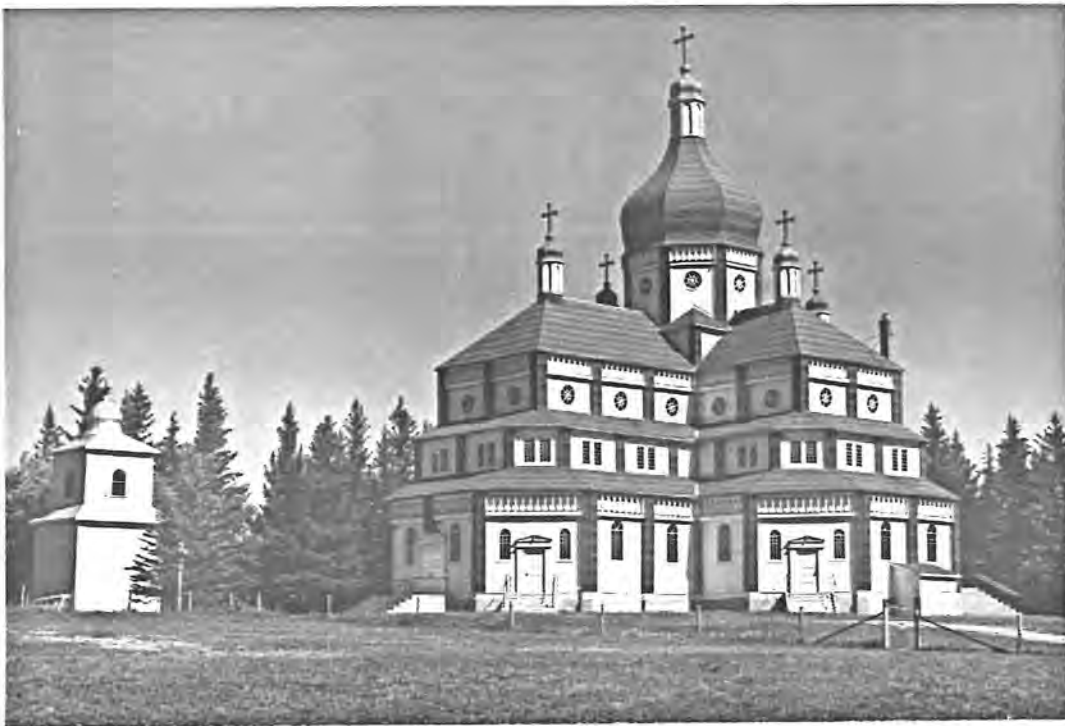
Plate 47. St. Mary's Ukrainian Catholic Church, Mountain Road (1924-25; burned 1966). (Provincial Archives Manitoba.)

The first sense the observer gains upon scrutinizing one of Ruh's churches is of grandeur touched by flamboyancy (Plate 47). This impression is especially reinforced when a comparison is made with the ancestral log and modest wood frame churches. Ruh's churches are large and the dynamism of forms and colours allies them closely with Ukrainian Baroque churches. A discussion of Ruh's churches, with reference to five of his most significant designs will underline the significance of his work.

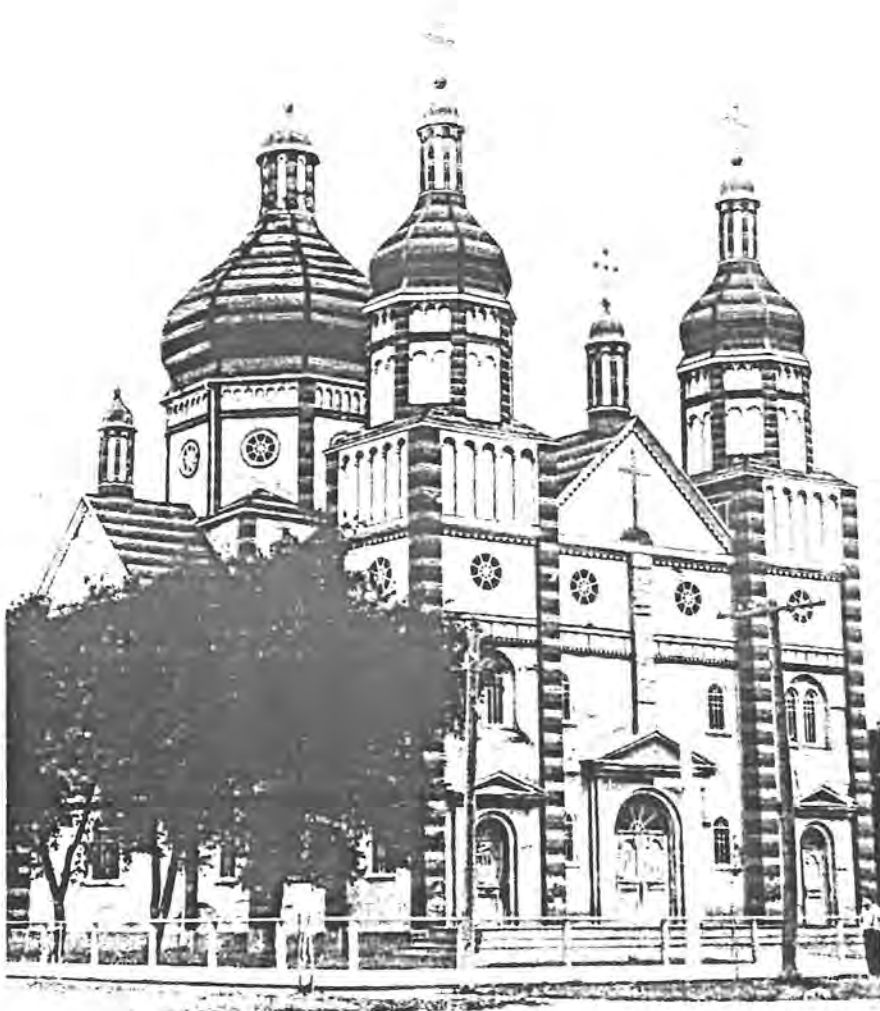
Plate 48. Church of the Assumption of the Blessed Virgin Mary, Portage la Prairie (1926-27) as it looked in 1948. The church was demolished in 1983.

The use of the twin flanking towers, capped with banyas was one of Ruh's most popular motifs, used on nearly all of his churches built after 1930. The two small banyas in conjunction with a large central dome represent the Trinity of Father, Son and Holy Ghost. There was always a

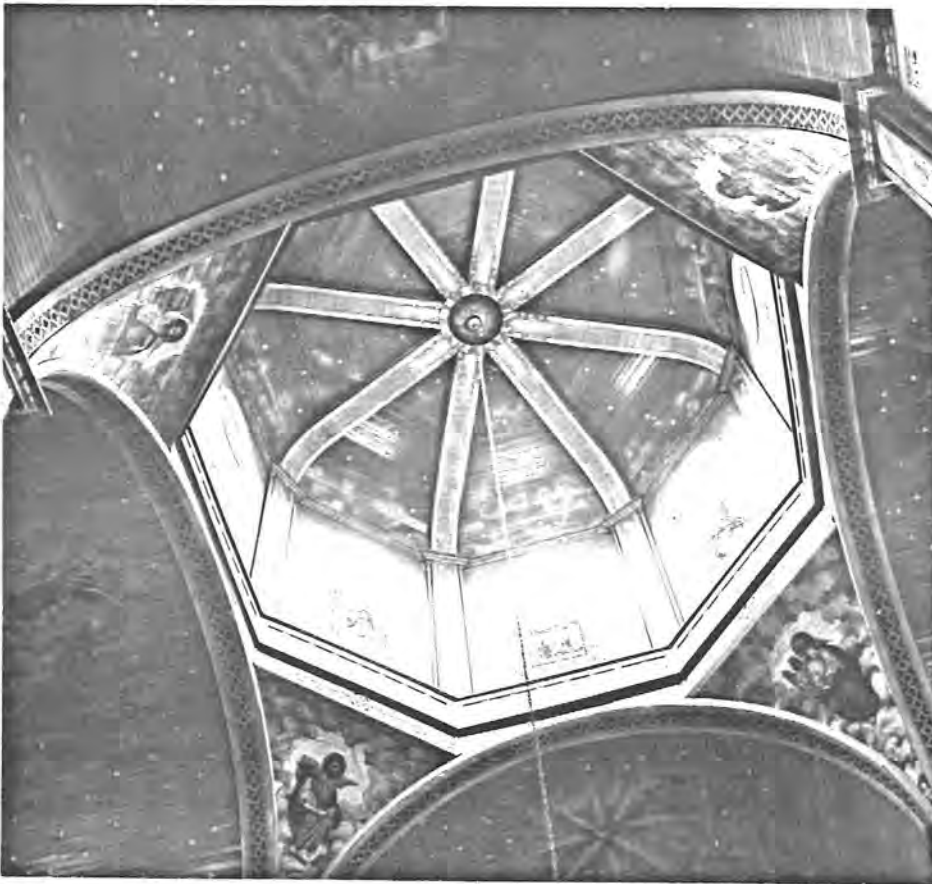
Plate 53. St. Mary's Church, Mountain Road. Each of the pendentives beneath the dome had a figure painted on it. (Provincial Archives Manitoba.)

provision in the plan for the construction of a large dome at the central crossing; although often this ambitious feature failed to materialize. The alternating shingle pattern, originally evident for example on the Winnipegosis church, gave a polychromatic effect to many of his domed churches. Inside the church the transition from the square crossing to the octagonal drum of the dome was achieved by squinches (Plate 53). At the far end of the church, at the top of

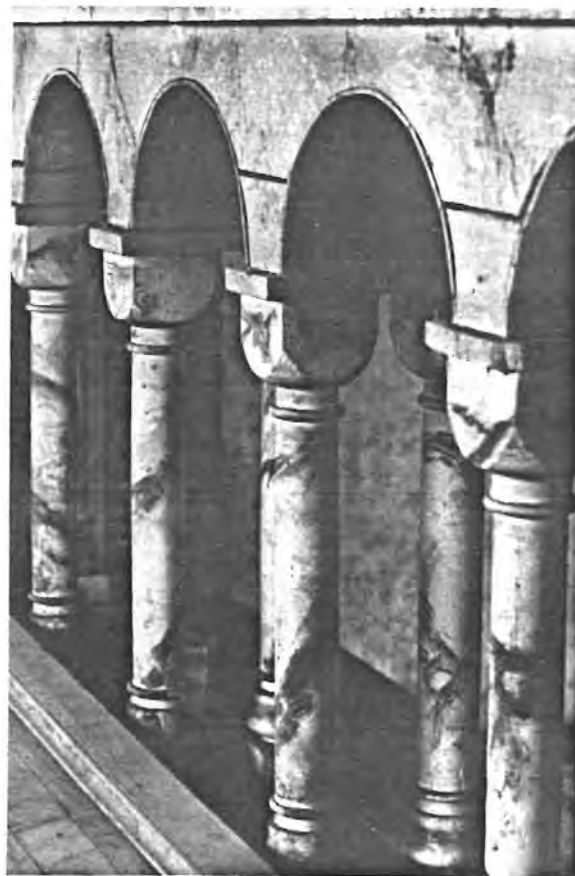
Plate 55. Church of the Assumption, Portage la Prairie. The balustrade of the cantor's loft, with its miniature columns and arches reflects the blind arcade motif which Ruh made use of on the exterior.

Twinned arched windows were a favourite with Ruh and can be seen on nearly all his churches. Door openings were also round-arched, and often fitted with fan light transoms. Ruh frequently used a blind arcade as a decorative element in the twinned façade towers, around the dome drum and below the main dome. Variations on the blind arcade motif were also used in a variety of other situations, particularly in the panels of the drum and inside the church, where it would reappear as a decorative frieze or a column pattern on the balustrade and railings (Plate 55).

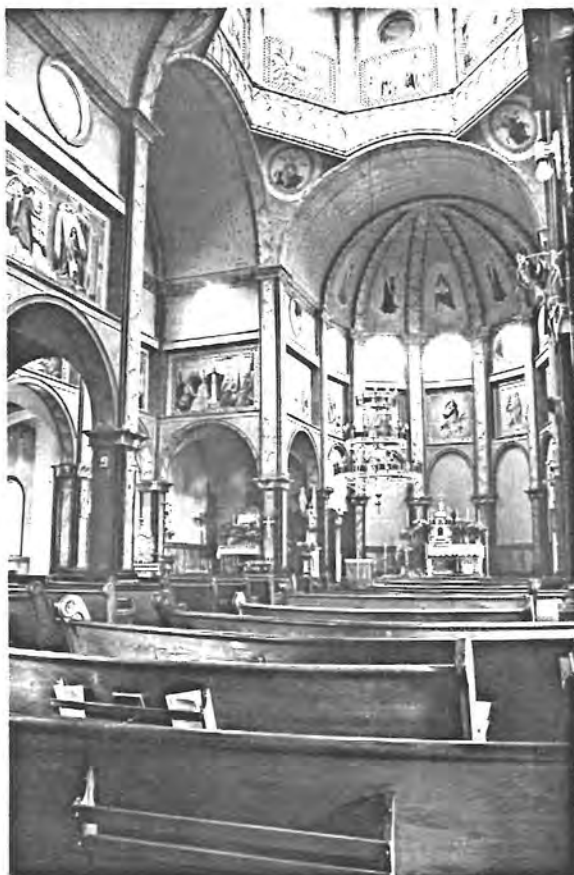
Plate 56. Church of the Assumption, Portage la Prairie. View of the central crossing. Also visible is the apsidal form of the chancel with its half dome and the barrel vaulting of the nave and transepts.

the nave and transept ceilings were constructed as barrel vaults (Plate 56); the ceilings of the aisles were groined; the round arches were continued in smaller areas. In his larger churches - as at Mountain Road, Portage la Prairie and Cook's Creek - arcaded side aisles were augmented by semi-circular arches with square columns (Plate 57). The curves of these arches were often enhanced with exaggerated ribbing (Plate 58). A unique arched element that appears in the Winnipegosis church was the cantor's loft above the entrance to the church. While Ruh included a cantor's loft in all his
