Manitoba  
Culture, Heritage  
and Recreation  
Historic Resources

# UKRAINIAN CHURCHES OF MANITOBA: A BUILDING INVENTORY

This examination of the architectural resources and the development of a typology of Ukrainian churches is based on material gathered for the Manitoba Heritage Council in February and March 1983 and on an inventory of the structures derived

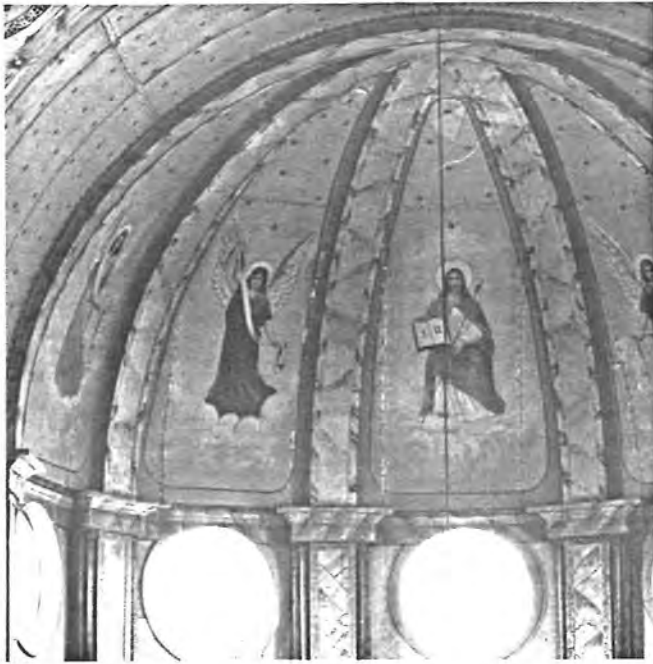
Plate 58. Church of the Assumption, Portage la Prairie. The accentuated ribbing of the dome and half dome is a particular design element which Ruh made use of repeatedly.

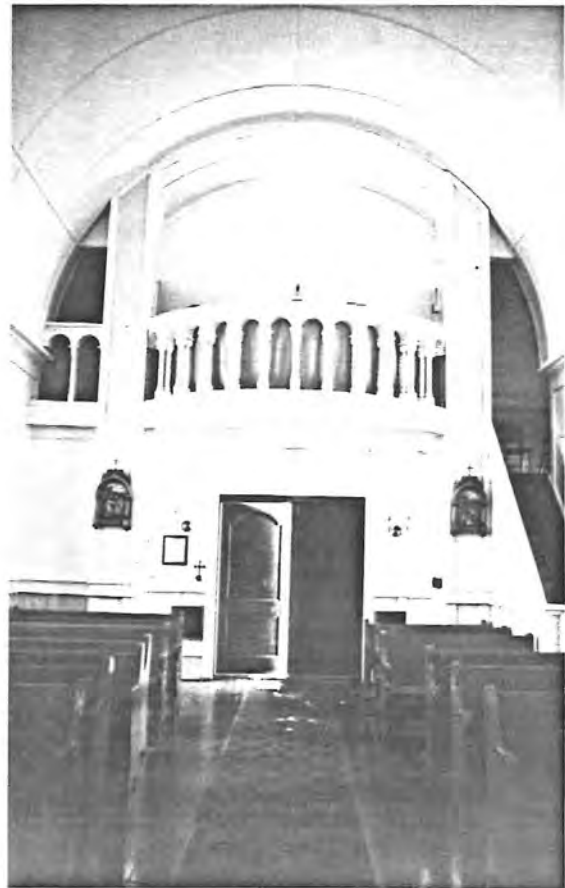
Plate 59. Ukrainian Catholic Church of the Holy Ascension, Winnipegosis. Cantor's loft.

churches, the loft at the church in Winnipegosis is quite compact and the balustrade is bowed out to increase both the capacity and dramatic affect (Plate 59).

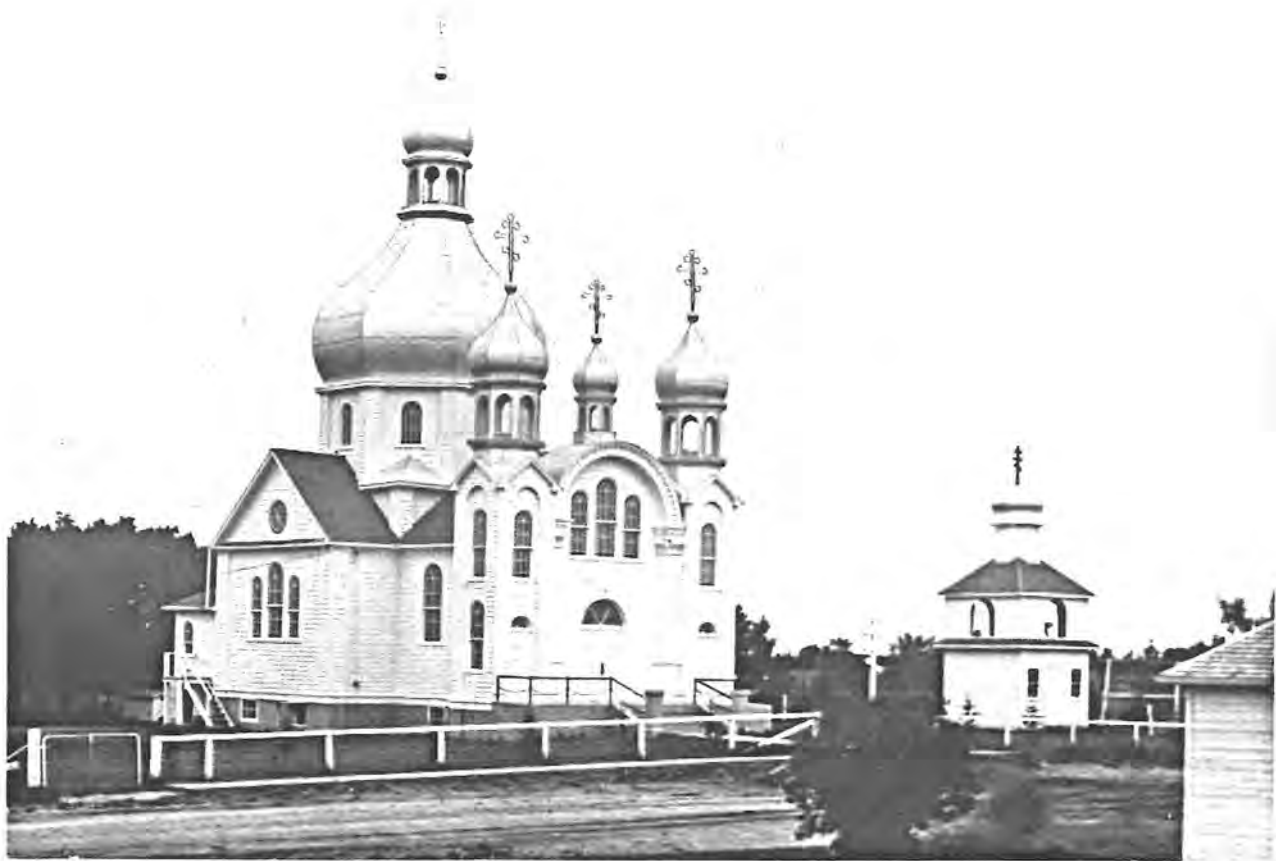
Plate 61. St. Michael's Ukrainian Greek Orthodox Church, Sandy Lake (1944-48).

St. Michael's Ukrainian Orthodox Church in Sandy Lake (1944-48) is a striking building which bears some general similarities to Father Ruh's "cathedrals", but springs from a slightly different sensibility (Plate 61). As in Ruh's designs the straightforward progression of spaces -- vestibule, nave, short transepts and apse -- are clearly expressed at Sandy Lake.

In contrast to Father Ruh's predilection for a triangular pediment, a curved pediment with hounds-tooth edging graces the Sandy Lake Church. The semi-circular motif is pursued throughout the building, especially at window and door openings. The structure is dominated by a towering dome. On the entrance facade two large banyas flank a smaller central banya, all of which are crowned with filigreed Orthodox Crosses. While the church exterior is not as flamboyantly decorated as many of Father Ruh's churches, the clean crisp design is nevertheless an elegant one.

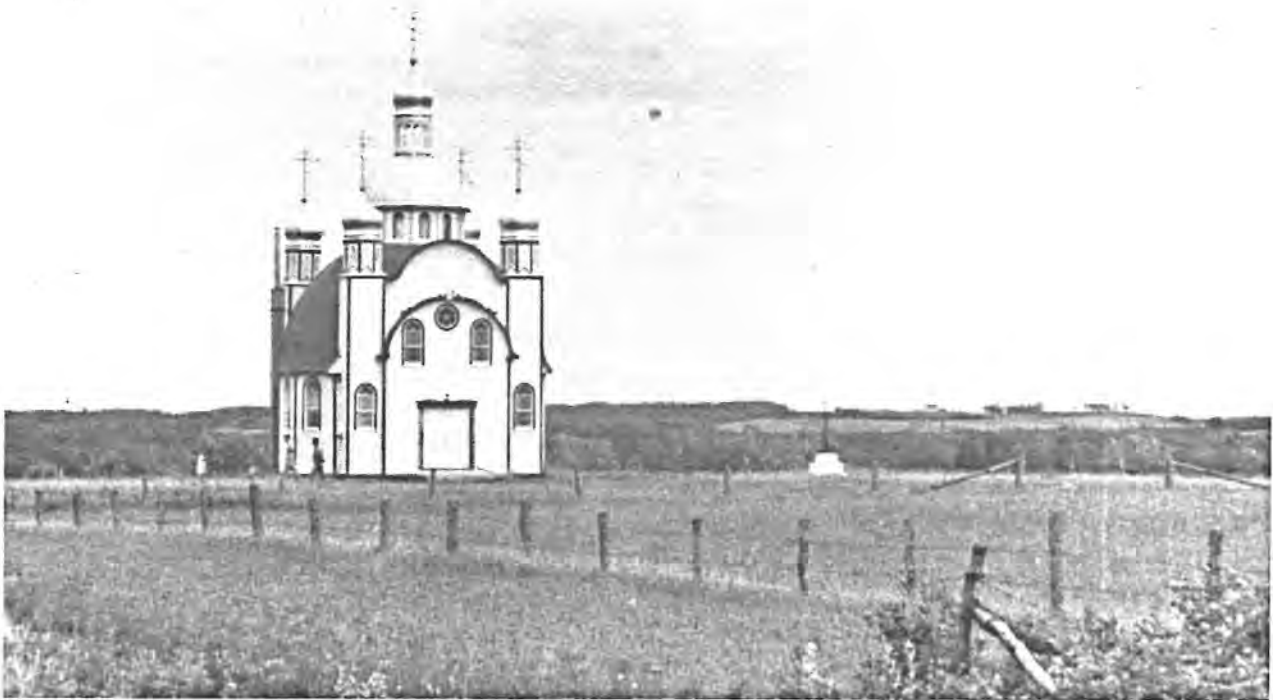
Plate 62. Holy Trinity Greek Orthodox Church, Shortdale.

Holy Trinity Ukrainian Orthodox Church in Shortdale is a compact, tall, building whose isolation on a slightly rolling landscape makes it a special local landmark (Plate 62). The traditional progression of internal spaces is expressed in this design, which is, nevertheless, a unique response to that tradition. The large dome is truncated at the front façade, creating a heavy central form, akin to the Hagia Sophia in Constantinople. A smaller dome pierces this expansive shell to light the interior. Four corner towers enclose the largest dome and their capping banyas provide a forceful vertical expression. The banya atop the central

dome creates a deft punctuation to the whole structure.

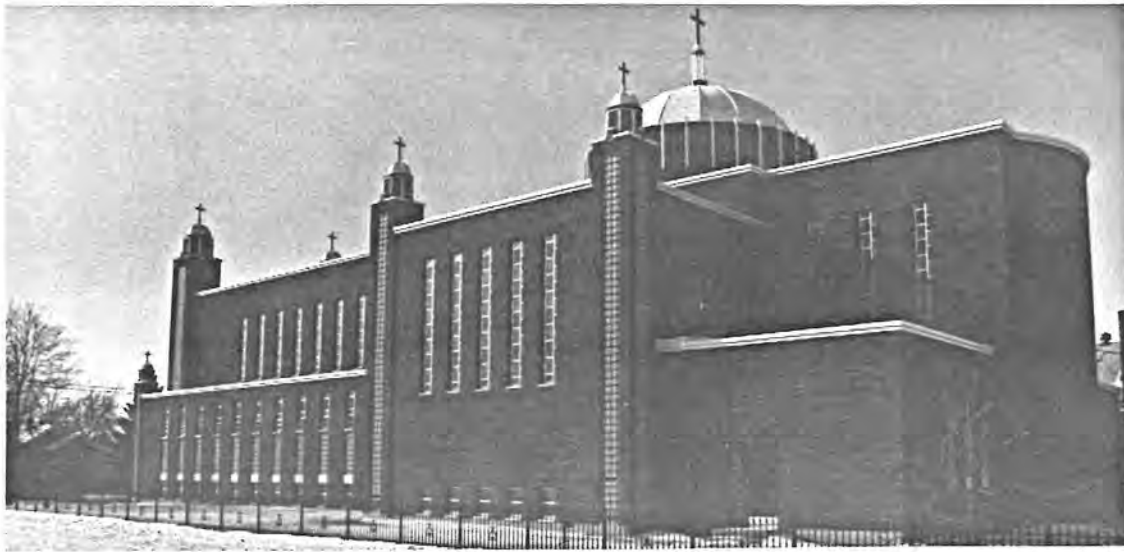
Plate 67. Blessed Virgin Mary Church. The cruciform plan is evident here and the dome is an important element of the design. The chancel is integrated into the main body of the

building. Although the elements are reinterpreted, the large massing characteristic of Ruh's churches is present in Deneka's design.

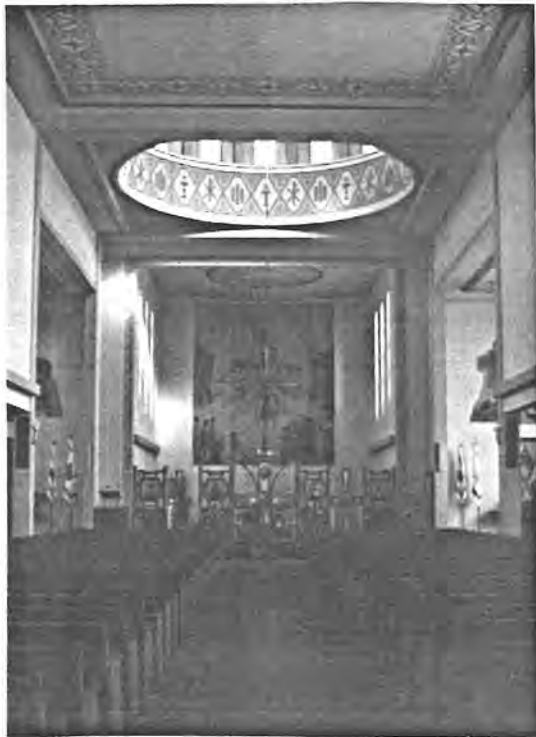
Plate 69. Holy Ghost Ukrainian Catholic Church, Beausejour. Deneka again casts the familiar forms of

Ukrainian churches -- the dome, the round arches and the dramatic bulk -- into striking modern idioms.

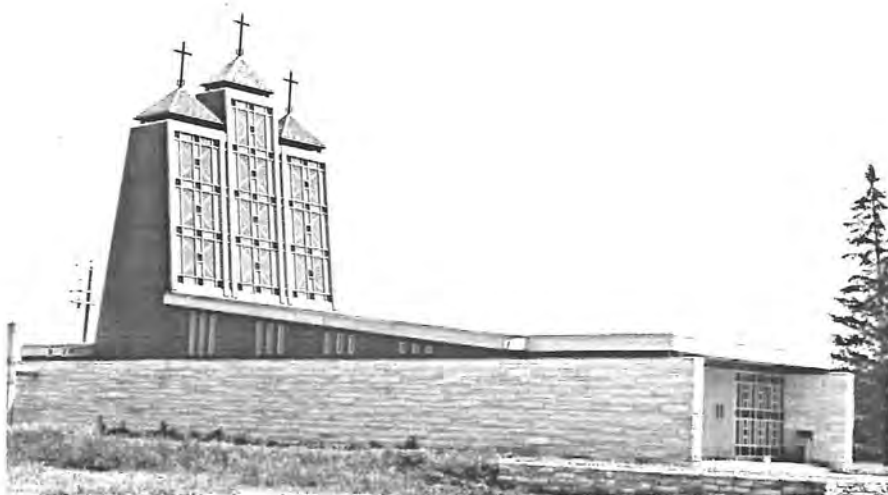
Plate 70. St. Michael's Ukrainian Catholic Church, Tyndall. The low slung modernism apparent in this church is strongly contrasted with the

vertical elements that recall the traditional dome-banya combinations of earlier Ukrainian churches.

its effect on the majority of subsequent buildings. Although this transition was felt in Ukrainian church design, architects on the whole found an anchor in tradition, searching for new ways in which to interpret traditional elements. New floor plans and building shapes emerged as the result of the efforts of men such as Victor Deneka, who designed the Ukrainian Catholic Church of the Blessed Virgin Mary, Winnipeg (Plates 67 and 68) and Holy Ghost Ukrainian Catholic Church, Beausejour (Plate 69); with Radislaw Zuk in his designs for St. Michael's Ukrainian Catholic Church, Tyndall (Plate 70) and Holy Family Ukrainian

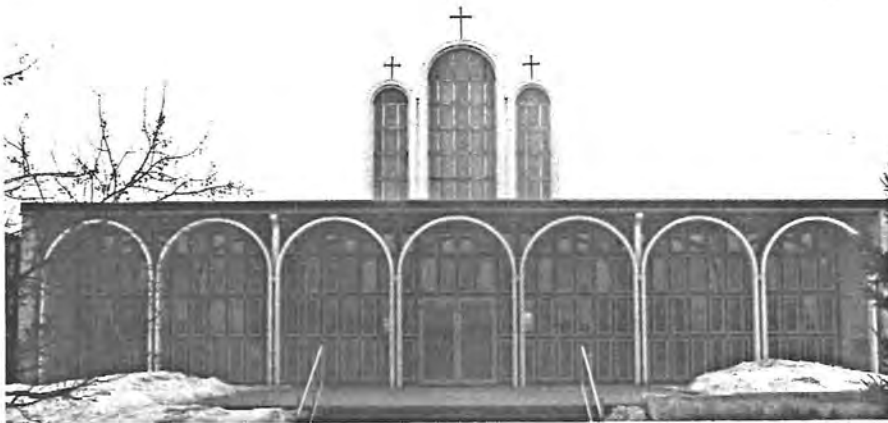
Plate 71. Holy Family Ukrainian Catholic Church, Winnipeg. Zuk reiterates the dynamism of horizontality and verticality in this design, crowning the towers with graceful arches.

Catholic Church, Winnipeg (Plate 71); and with Alex Nitchuk of Green, Blankstein, Russell Associates, Architects and Engineers, for the Ukrainian Catholic Church of St. Nicholas, Winnipeg (Plate 72). These Ukrainian Canadian architects combined the form and functionality of modern design with details that recalled the earliest examples of Ukrainian church architecture. In most the result has been new churches that are innovatively conceived, modernly convenient and traditionally appointed.

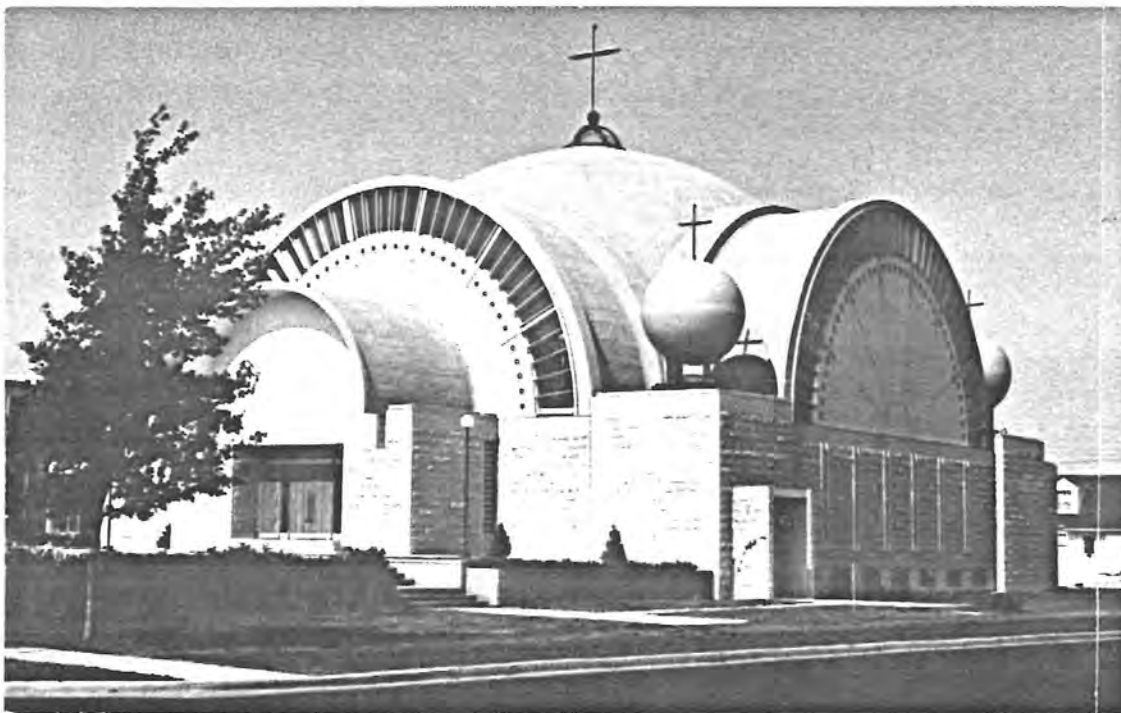
Plate 72. Ukrainian Catholic Church of St. Nicholas, Winnipeg. The ubiquitous dome of Byzantine churches becomes the dominant form in this

design. Indeed, the building quite clearly resembles, in conception, the Church of the Hagia Sophia in Constantinople.
